Product Innovation Report

Yaw Roller Nut

14 March 2017

1. **Product Innovation Summary:** Yaw Roller Nut, eliminates failure mode resulting from imperfect wrench-turning technique.

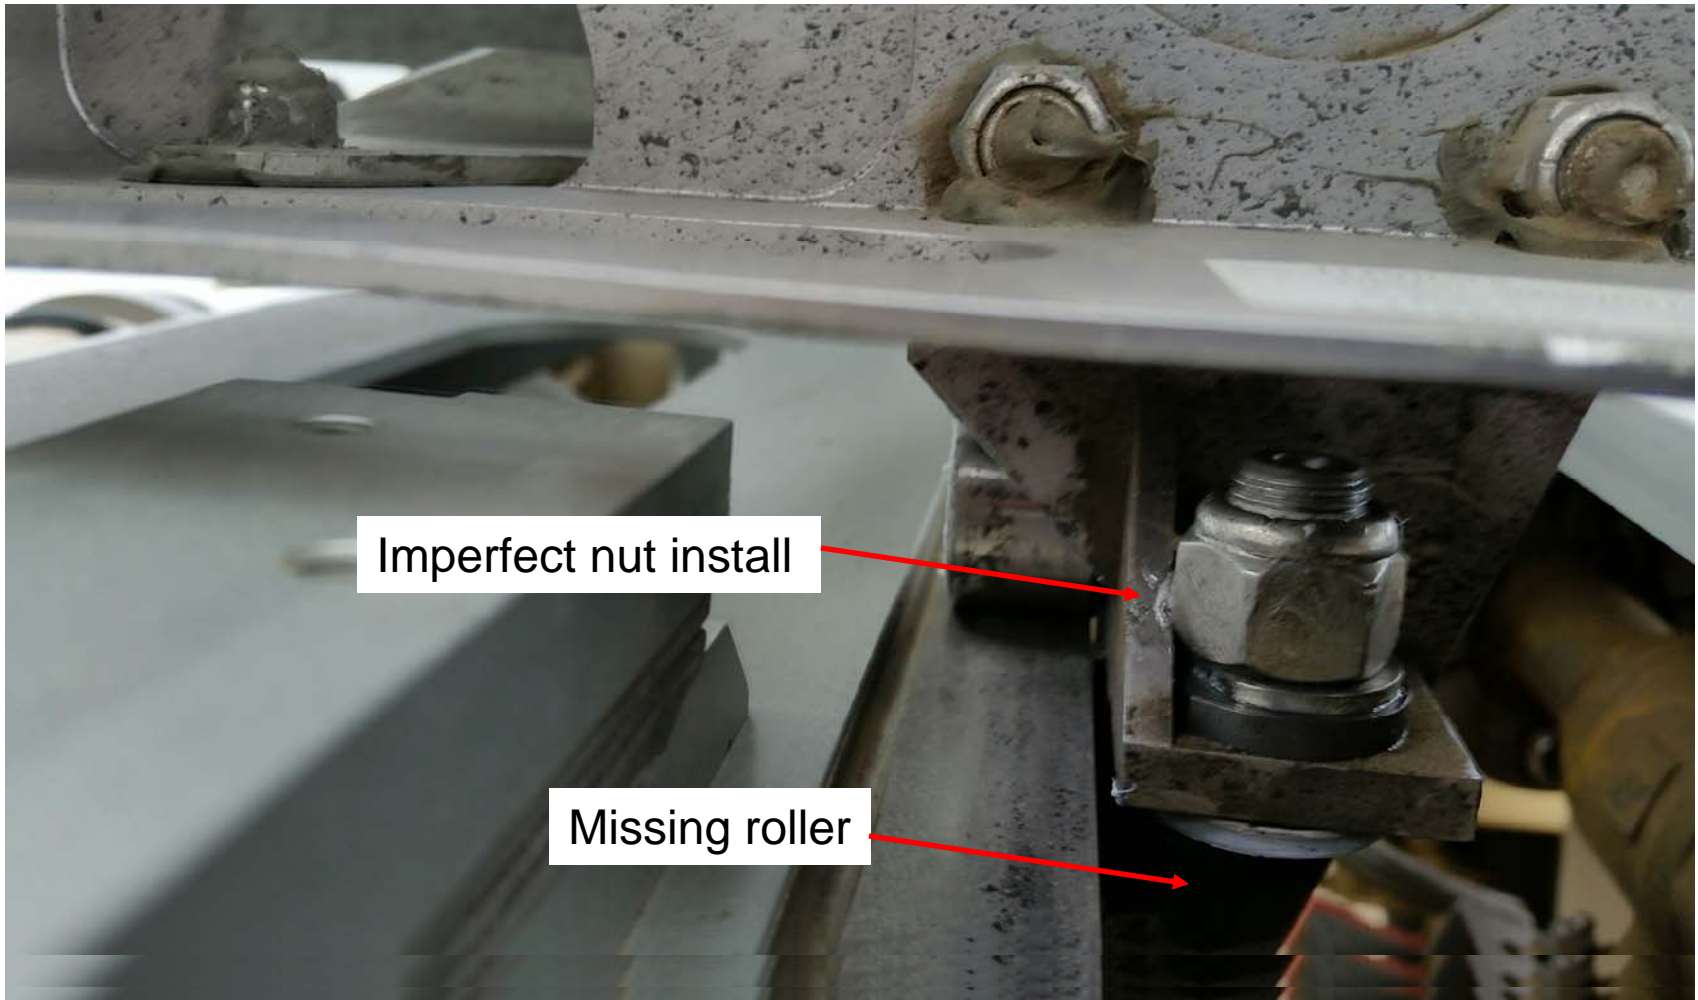
Boardman Test Range, 9 March 2017

- 1 failure occurred during assembly
- 3 failures occurred during launcher check-out inspection
- **March 2017 update:** On 9 March 2017, a yaw roller failed during a live (N20-equipped aircraft) customer demonstration. The launch was reported “slow” by the flight ops personnel, and the observed climb-out confirmed this. The aircraft pitched down and **descended** off the launcher to build airspeed, threatening ground impact for several seconds before finally climbing to safe altitude. The failed roller was found, post launch, many meters downrange.

Live Launch Failure During Customer Demonstration

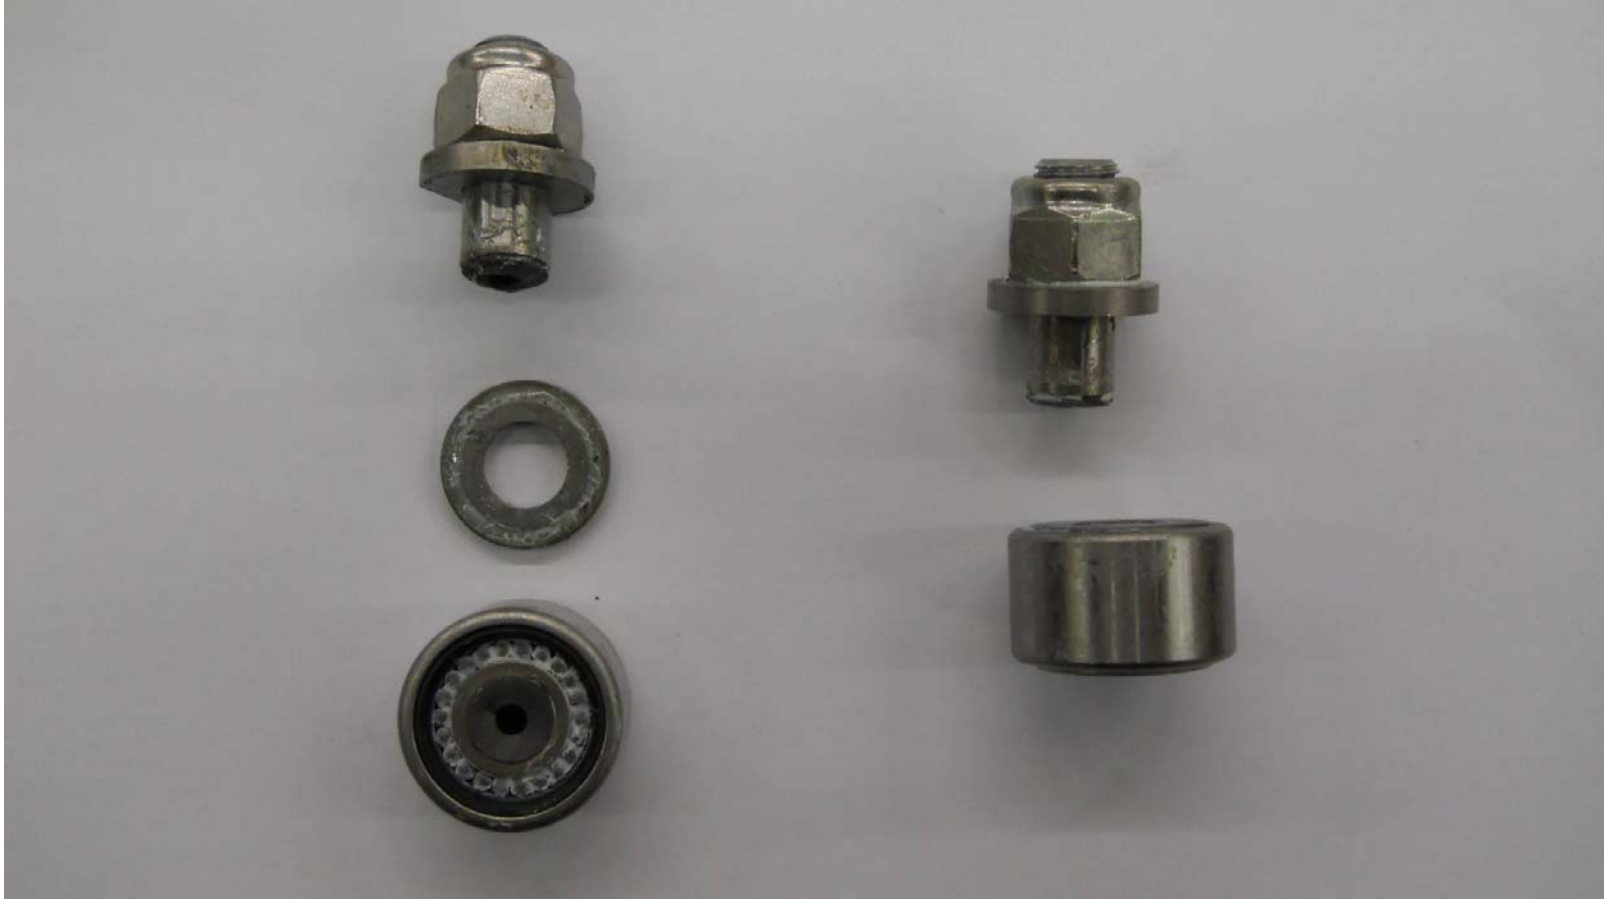
Failed Roller Stud Samples;

reveal evidence of failure due to overload; in each case pronounced scraping of the aluminum gusset confirms nut was imperfectly held during installation.

- When a standard COTS hex nut is used to secure a yaw roller, it can bind along the caster bracket gusset surface, inducing a residual bending moment exceeding 1000 in-lbs at the notched section of the roller stud. The tensile stress at the notch exceeds 285ksi (the ultimate strength of 440C material), and the stud fails.
- Depending on machining tolerance, install torque and geometry, it's also possible to have install stress in the 200-250ksi range, and the additional stress of loading the carriage onto the Mark 4 track causes the total stress to exceed 285ksi, and the shaft fails.

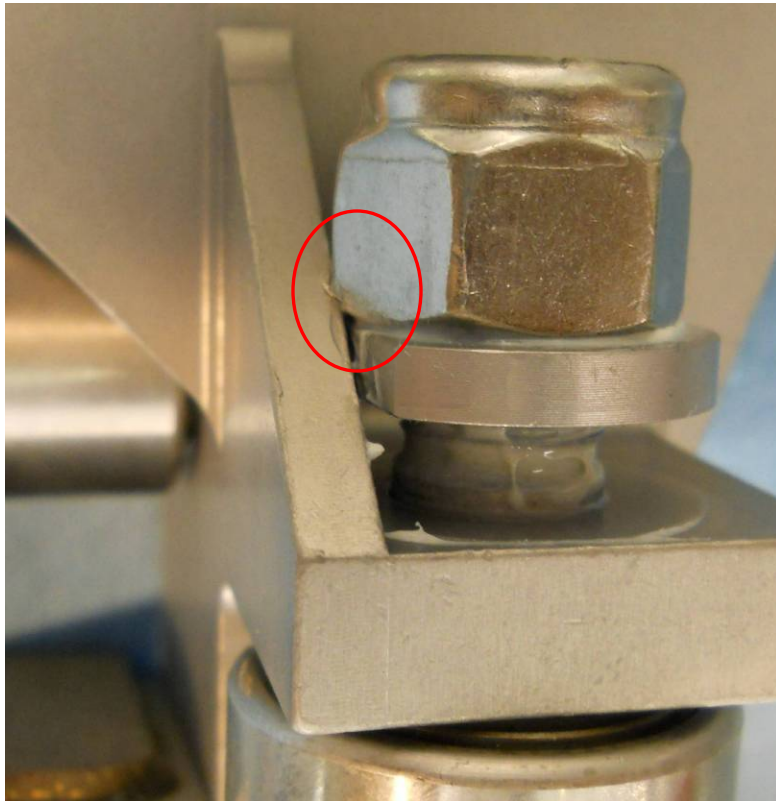
Baseline; careful, 2-wrench technique
is required to prevent nut binding
