Product Innovation Report

Pack out Tray Cam-lever Security

1. **Product Innovation Summary:** Modification of the Pack out Tray build procedure to ensure the cam-lever is securely fastened to the pack out tray rear extension.

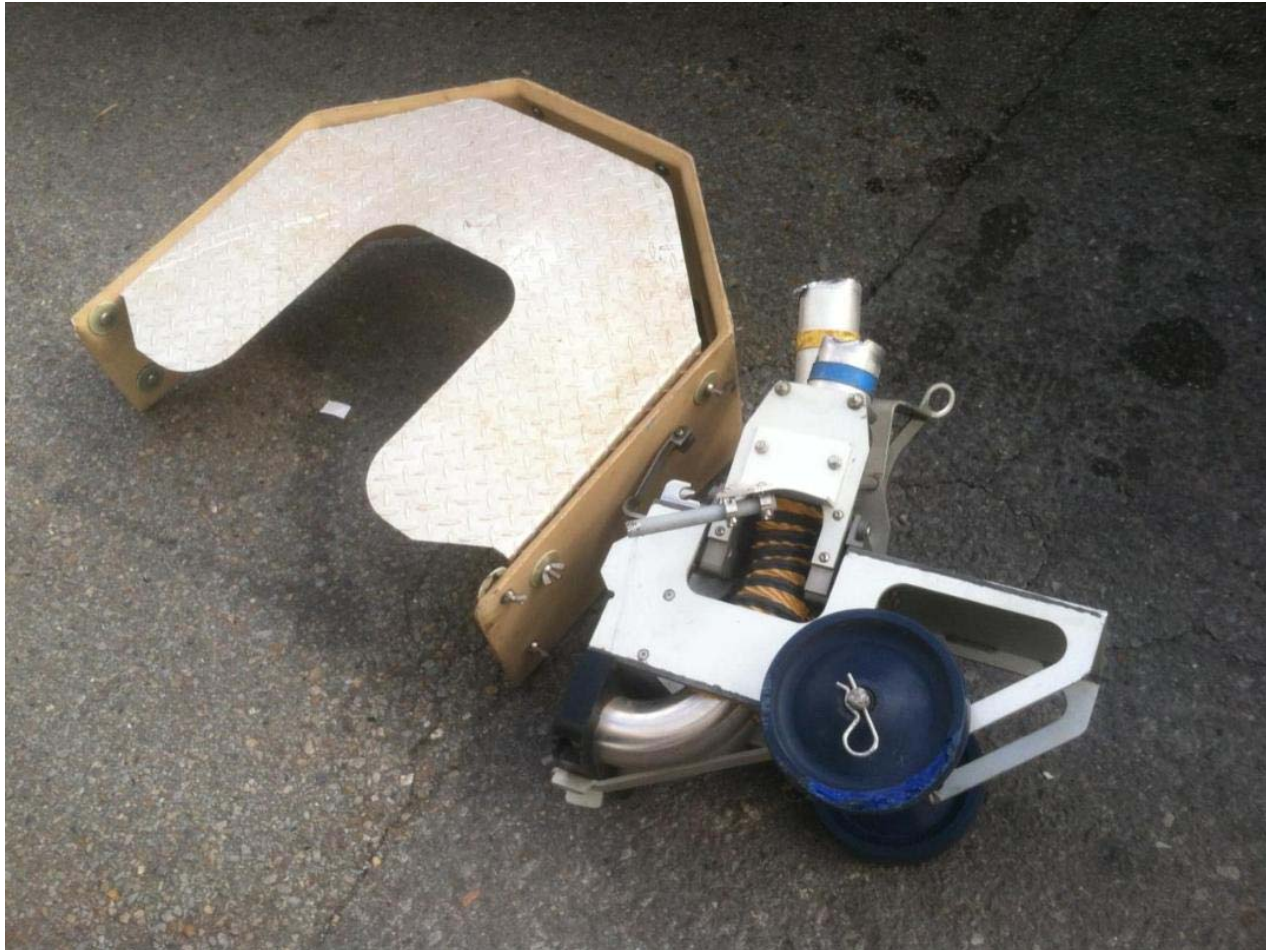
Example of Mark 4 Launcher damage linked to unsecured load during transport

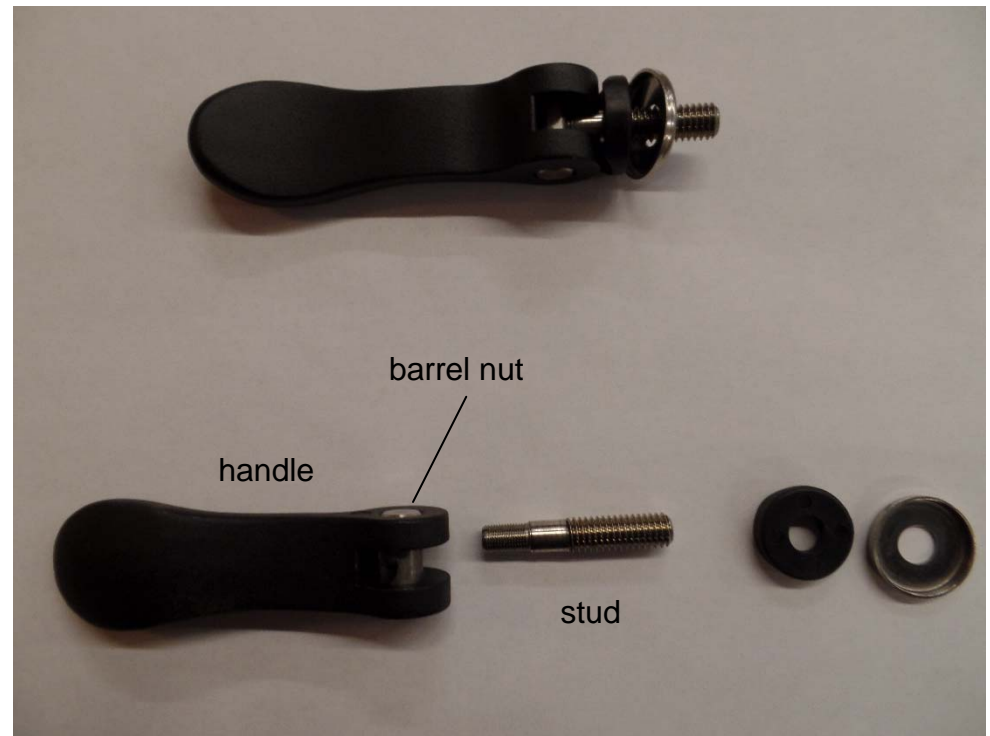
For transport, the pack out tray is secured to the launcher with a stainless steel rear-extension slid under the forward beam of the carriage. The rear-extension is locked in place with a cam handle.

The cam handle is comprised of several parts. The handle and barrel-nut thread onto the stud, which allows the user to adjust the over-center force. When the cam lever is not “cammed down” or locked, the lever and barrel nut can become unthreaded from the stud and lost.

Once the lever is lost, the pack out tray cannot be secured to the launcher. It can fall off the trailer during transport, damaging removable launcher parts and endangering other vehicles.
