Product Innovation Report

Yaw Roller Nut

14 March 2017

1. **Product Innovation Summary:** Yaw Roller Nut, eliminates failure mode resulting from imperfect wrench-turning technique.

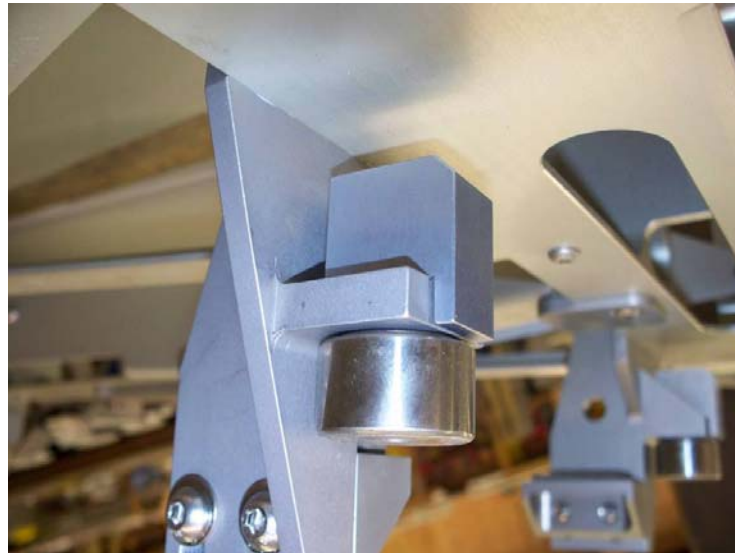
Yaw Roller Nut

Failure History

- At least 4 production rollers have failed due to improper installation. In all cases, installer was fully qualified, had proper training and years of experience in this field

- 1 failure occurred during assembly
- 3 failures occurred during launcher check-out inspection
- **March 2017 update:** On 9 March 2017, a yaw roller failed during a live (N20-equipped aircraft) customer demonstration. The launch was reported “slow” by the flight ops personnel, and the observed climb-out confirmed this. The aircraft pitched down and **descended** off the launcher to build airspeed, threatening ground impact for several seconds before finally climbing to safe altitude. The failed roller was found, post launch, many meters downrange.
